## **MGWSP Report**

Isham Bypass

Pre-construction Ecological Survey Report

**September 2011**

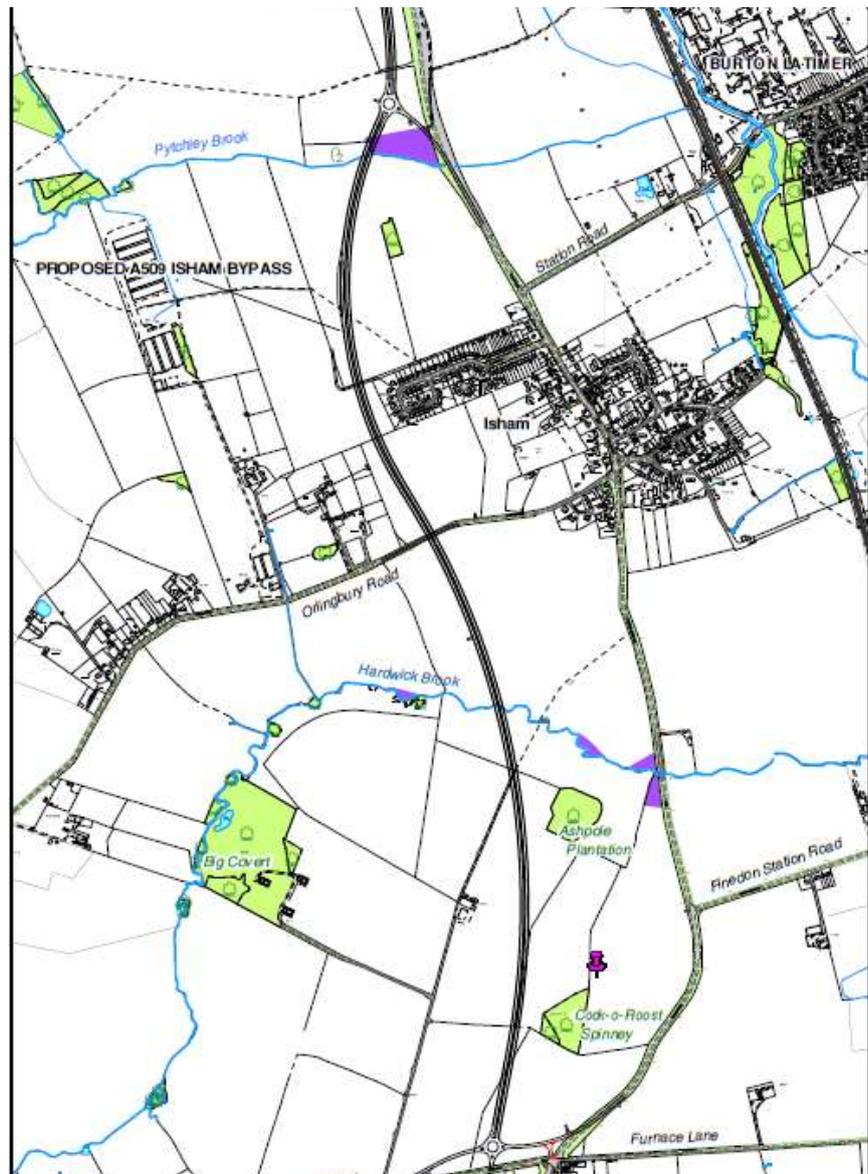
## Appendix Number 2: Reptile survey locations

During the walkover survey in August and September 2011 areas to be surveyed for reptiles were identified, these included the areas previously surveyed as well as new additional areas. The areas potentially suitable for reptiles are shown in Appendix 2. The walkover survey also identified a grass snake skin near the Cock-o-Roost Spinney.

Due to the time of year reptile traps cannot be placed until spring 2012. Traps will be placed in the areas identified in Appendix 2 and checked regularly for reptiles.

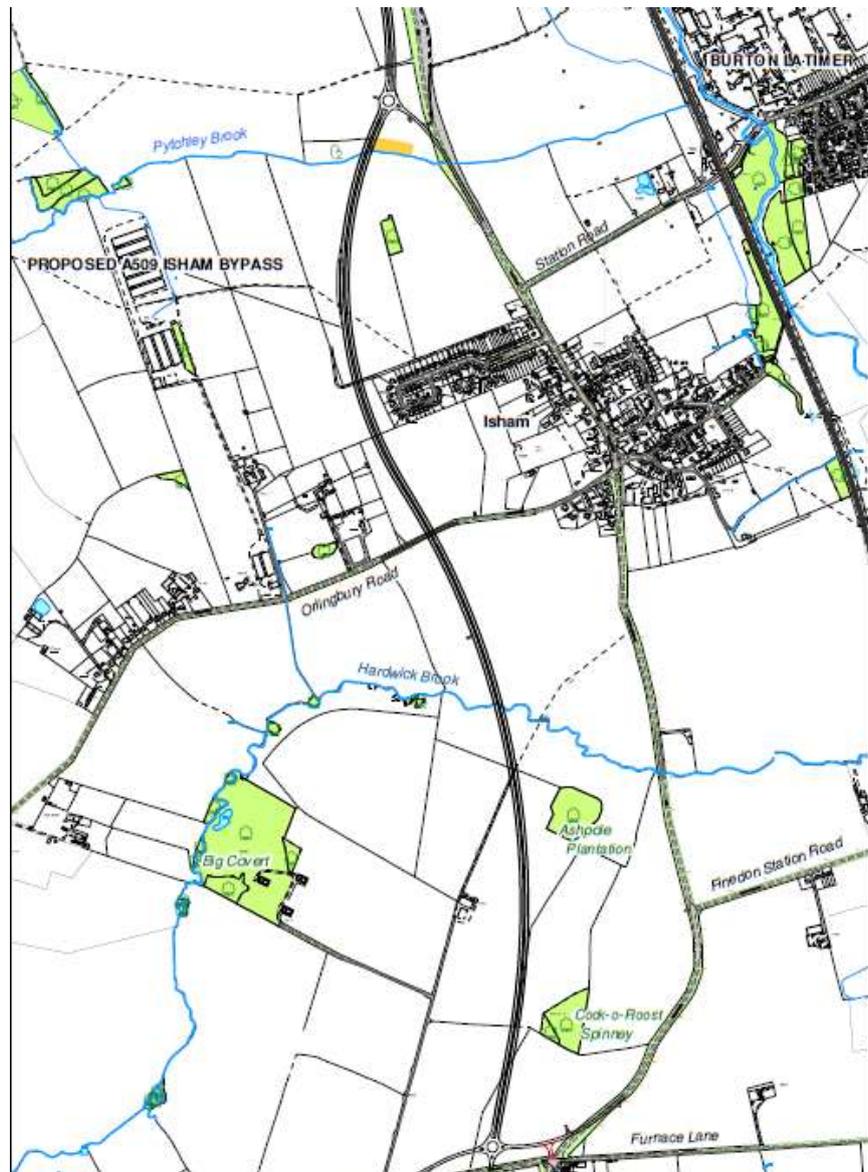
# Appendix Number 3: Invasive and Injurious Species

A small area of ragwort was found along a field edge and a small area along the river near the Great Harrowden Bridge No. 1, which is shown in Appendix 3.

Chemical control of ragwort using an approved herbicide is the most effective method of control.

Ragwort can be hand pulled by the root, although this is not as effective as chemical treatment, as roots remaining in the ground can grow into new plants.

Any waste from ragwort removal should be double bagged and disposed of appropriately.

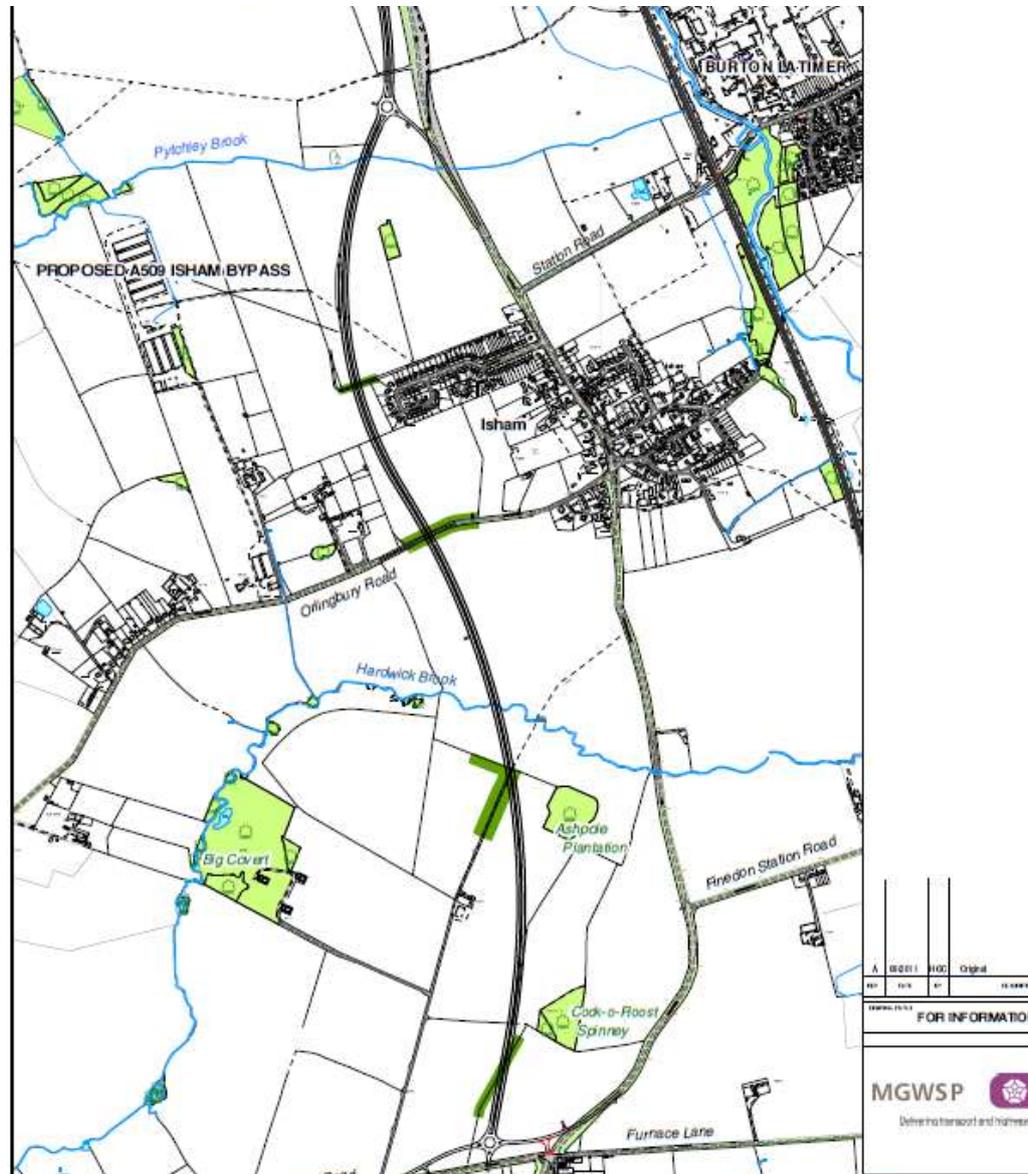
# Appendix Number 4: Hedgerow Survey Results

Seven hedgerows were identified as requiring further surveys in total along the route of the proposed road using the 'Standard Procedure for local surveys in the UK', prepared on behalf of the Steering Group for the UK Biodiversity Action Plan for Hedgerows. These hedgerows are shown in Appendix 4.

These hedgerow surveys are to be carried out between April and September.
