Wollaston School Science Block  
Bat Survey Report

For Wollaston School

14<sup>th</sup> December 2012

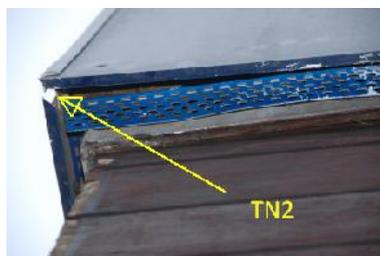
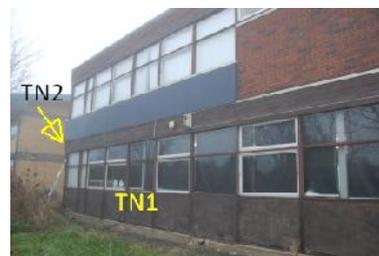
#### TN2

This is a gap at the west corner of the building between the ground and first floors where the over-panelling has parted. The resulting void was inspected by an endoscope camera.

It is understood that the work on the building will not be undertaken until next year, possibly during the summer holidays. It is therefore strongly recommended, as a preventative measure, that all the damaged areas identified are temporarily repaired to prevent bats or birds commencing roosting/nesting behind the cladding prior to building works commencing.

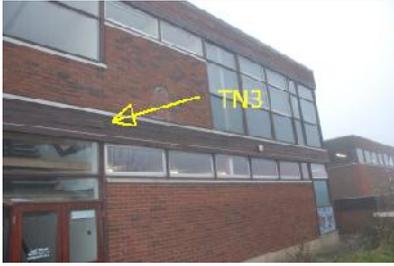
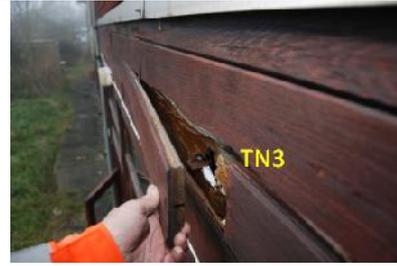
#### TN3

Above and below the first floor windows there is horizontal tongue, groove and veed boarding behind which is building paper and a thin layer of polystyrene.

On the south-west side, below the first window one end of a board has curled away from the studwork leaving a gap. There is a corresponding hole in the building paper behind the boarding. The gaps behind the boarding and building paper were both inspected with the camera.

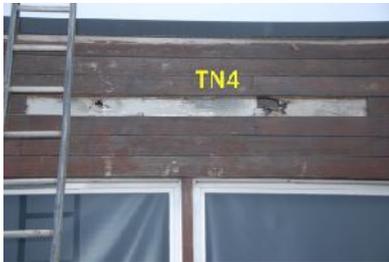
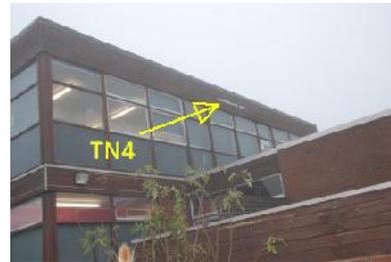
#### TN4

On the south-east elevation, above the corridor link, one of the horizontal boards above the Science Block first floor window is missing. There are two corresponding holes in the building paper and polystyrene insulation, giving access to the flat roof void. The void was inspected using bright lamps and camera.

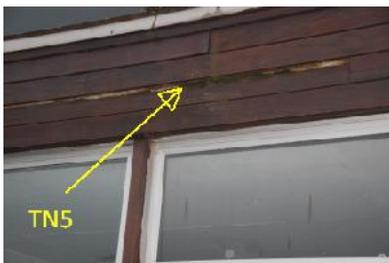
#### TN5

This is a section of horizontal board on the north-east elevation above the ground floor windows. The board has started to rot, but at the time of the survey this had not created a gap suitable for bats or birds to enter.

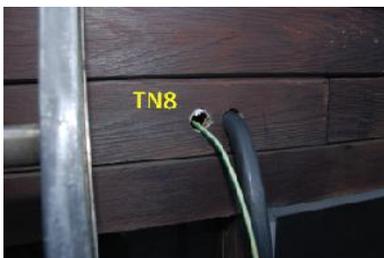
### TN8

Two oversized holes for electrical cables above the ground floor windows on the north-east elevation. One hole is large enough for both bats and birds to enter.
